## NATIONAL INTERAGENCY FIRE CENTER

### NATIONAL FIRE EQUIPMENT SYSTEM CACHE MEMORANDUM NO. 13-2

Subject: Recall, Hoseline Tee with Valve, NFES #0230

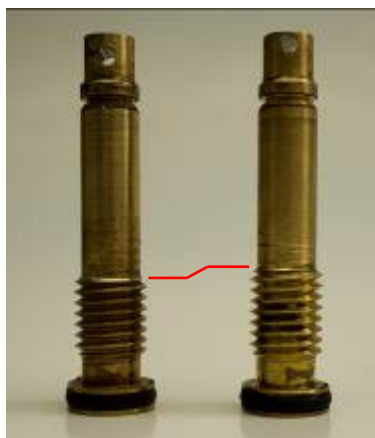
A manufacturing error in certain hoseline tees with valves (NFES #0230) was noted by the field, reviewed by the San Dimas Technology and Development Center, and confirmed by the manufacturer. The error resulted in a percentage of hoseline tees with valves manufactured by S&H Products that do not have the requisite number of threads on the valve stem (Figure 1). For affected tees, rotating the valve handle to a fully closed position causes the threads on the valve stem to run out and disengage with the valve body. This does not allow the valve to be easily reopened and constitutes a performance defect and possible safety hazard.

Figure 1— Comparison of threads on the valve stem; nonworking valve (left) and working valve (right). Note that the working valve stem has one full thread more than the nonworking unit

To determine if a hoseline tee should be replaced, simply rotate the valve handle clockwise to a full stop position. You should feel a hard stop. If the valve handle continues to rotate even after the valve is fully seated in a closed position, it must be replaced. The earlier video describes this procedure in detail: <http://youtu.be/NT81zJ2YzUg>.

S&H Products has agreed to repair or replace any affected hoseline tees. Send defective units directly back to the manufacturer for exchange/repair at the following address:

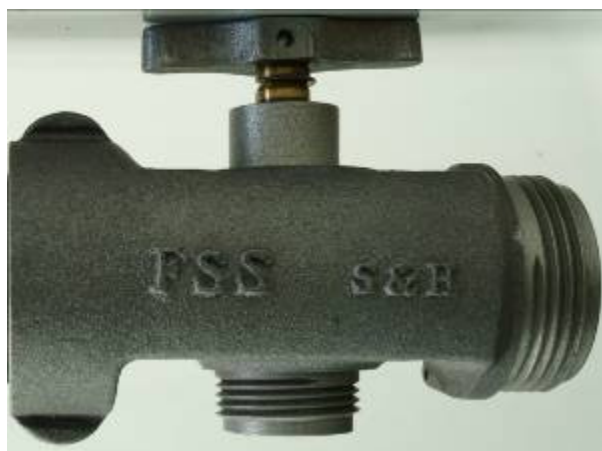
1. Manufacturer – S&H Products (Figure 2)

Figure 2--Hoseline tee from S&H Products

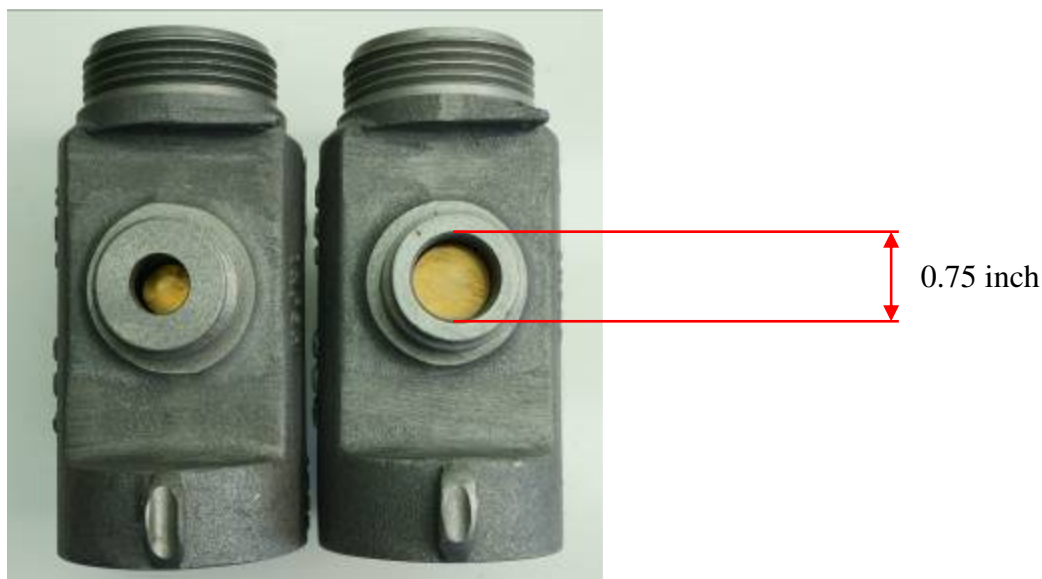
2. Branch Waterway Orifice – large diameter 0.75 inch waterway (Figure 3)

Figure 3--large 0.75 inch diameter on branch waterway for potentially affected tees (right) versus an unaffected tees<sup>a</sup> (left)

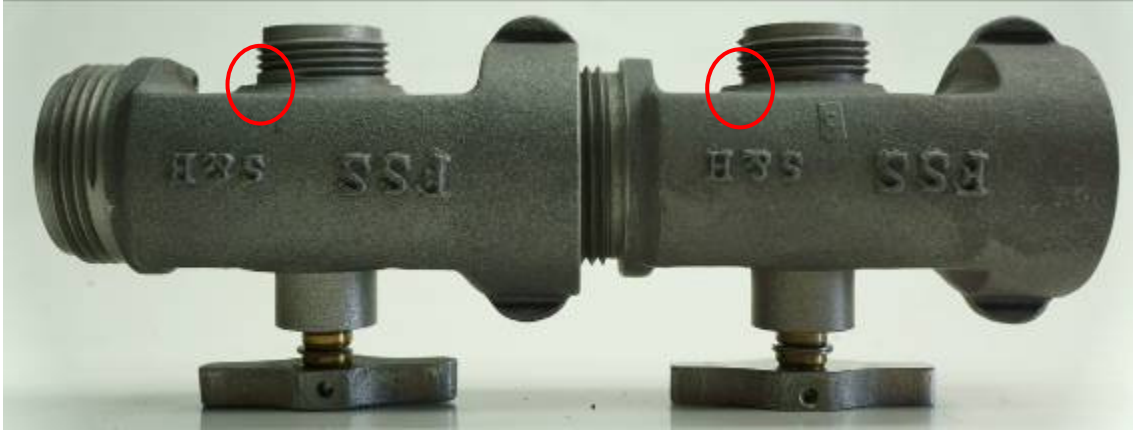
### 3. Lack of Thread Relief (Figure 4)

Figure 4--comparison between potentially affected tee (without thread relief; left) and unaffected tee (with thread relief; right)
